Contract #: 04-0120F4Cty: SF/ALA Rte: 80 PM: 13.2/13.9File #: 69.28**WELDING INSPECTION REPORT****Resident Engineer:**Siegenthaler, Peter**Address:** 333 Burma Road**City:** Oakland, CA 94607**Report No:** WIR-024571**Date Inspected:** 05-Jun-2011**Project Name:** SAS Superstructure**OSM Arrival Time:** 1900**Prime Contractor:** American Bridge/Fluor Enterprises, a JV**OSM Departure Time:** 700**Contractor:** Zhenhua Port Machinery Company, Ltd (ZPMC), Changxing Island **Location:** Shanghai, China**CWI Name:** See Below**CWI Present:** Yes No**Inspected CWI report:** Yes No N/A**Rod Oven in Use:** Yes No N/A**Electrode to specification:** Yes No N/A**Weld Procedures Followed:** Yes No N/A**Qualified Welders:** Yes No N/A**Verified Joint Fit-up:** Yes No N/A**Approved Drawings:** Yes No N/A**Approved WPS:** Yes No N/A**Delayed / Cancelled:** Yes No N/A**Bridge No:** 34-0006**Component:** OBG**Summary of Items Observed:**

OBG Trial Assembly

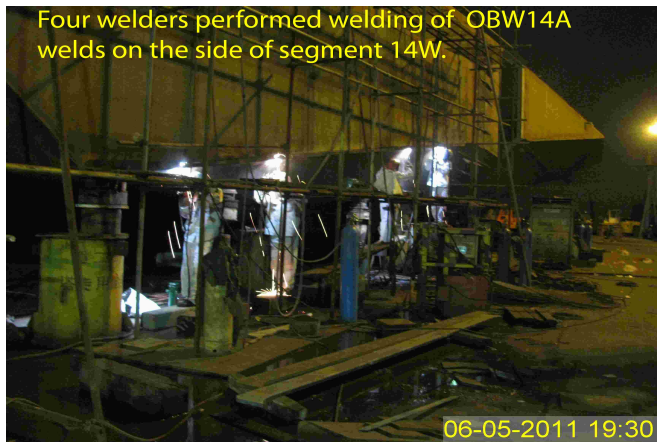
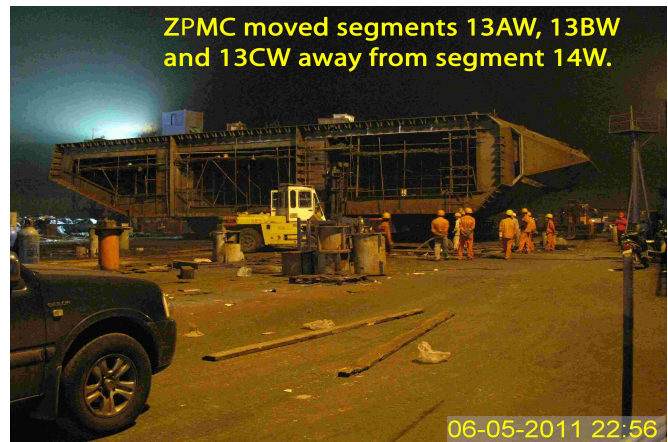
At around 22:15 hours ZPMC moved OBG segments 13W-A, B and C away from segment 14W for a distance of approximately twenty meters. See the photograph below for additional information.
